## ***Chapter 2 – Status of Water Quality in the Watershed***

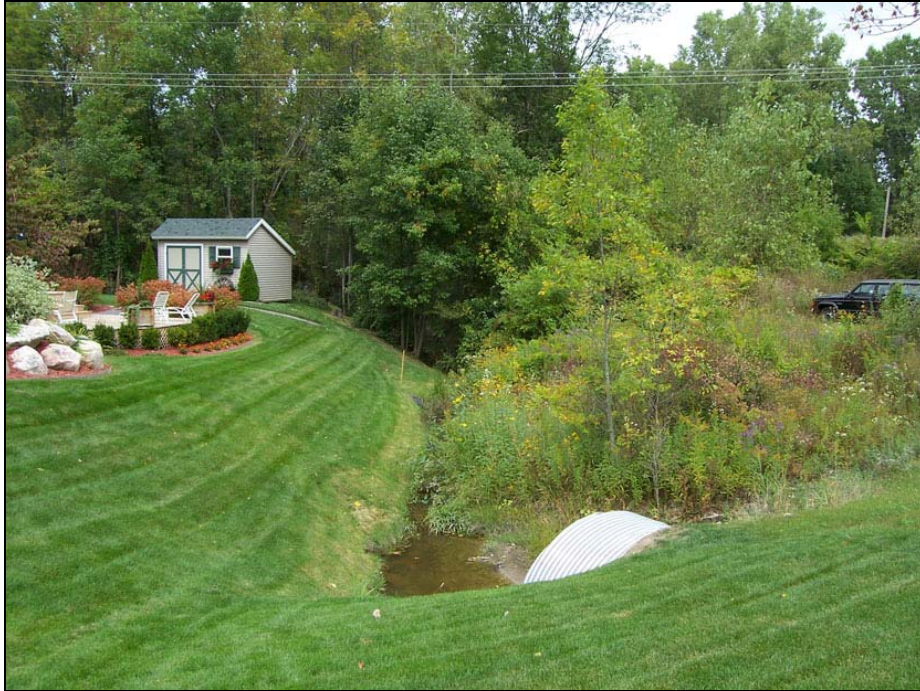
**Figure 2.1 Nonpoint Source Pollution Pathways in Residential Areas: Lack of Riparian Buffers** (photo taken along the Cuttle Creek in the SRD subwatershed)

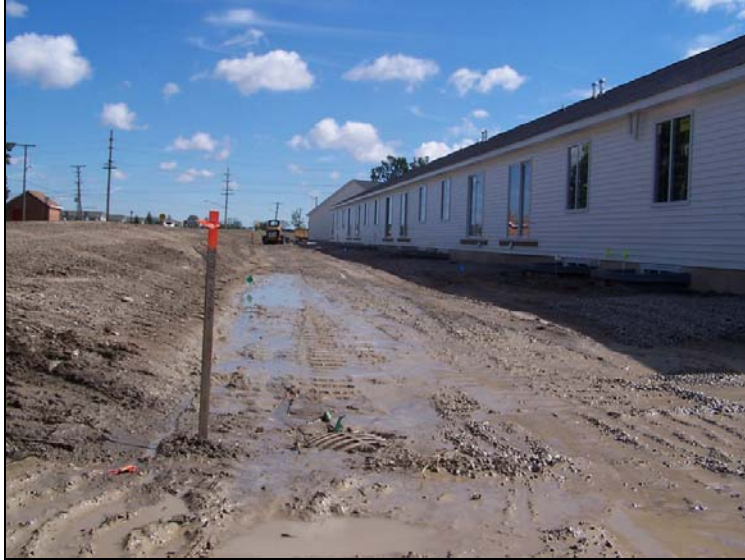
**Figure 2.3 Urbanized Source of Nonpoint Source Pollution: Offsite Soil Erosion and Sedimentation at Construction Sites** (photo taken of construction site at the corner of Bunce Avenue and Busha Highway in the SRD subwatershed)

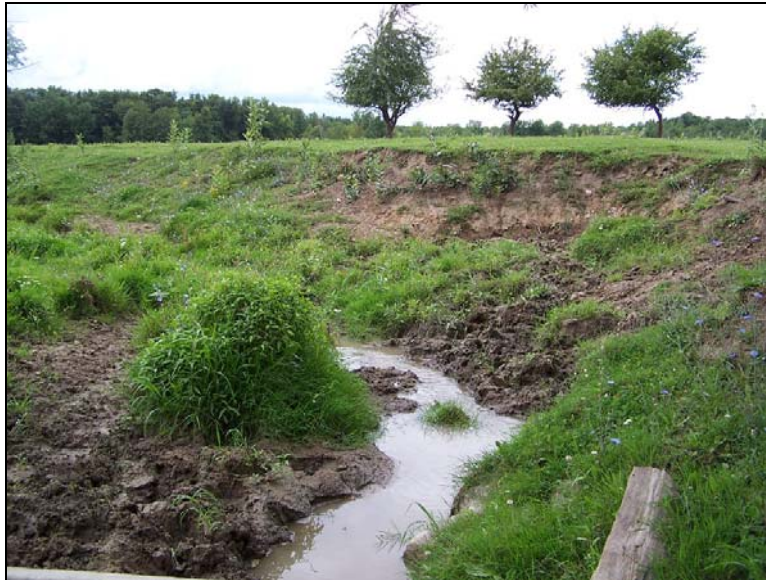
**Figure 2.4 Agricultural Sources of Nonpoint Source Pollution: Eroded Streambanks from Lack of Riparian Buffer and Cattle Access to Streams, and Pathways for Pathogens and Bacteria, Nutrients, and Pesticides into Area Waterways** (photo taken at Harris Road in the LHD subwatershed)

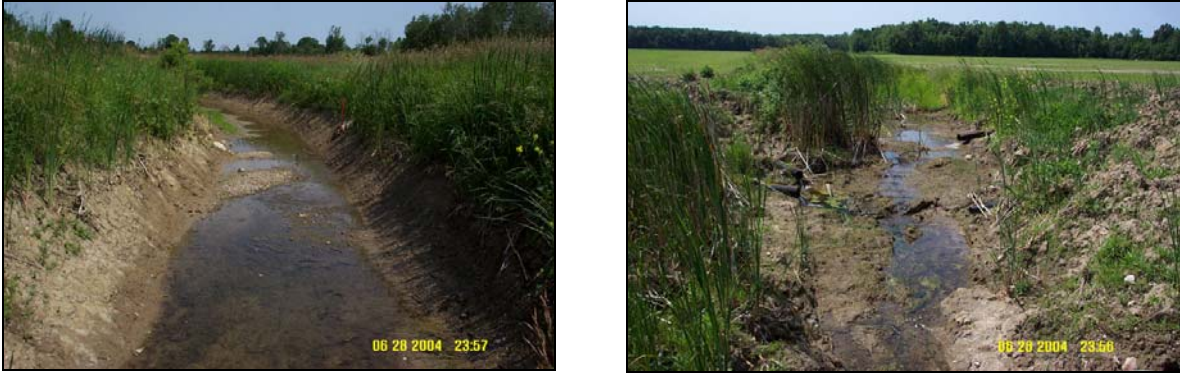
**Figure 2.5 Hydromodifications such as Ditching and Tile Drainage in Agricultural Areas Impact Watershed Hydrology by Increasing Stormwater Runoff Quantities and Decreasing Groundwater Recharge and Baseflows in Streams** (photos taken at Norman Road along Thomas Drain in the LBR subwatershed)

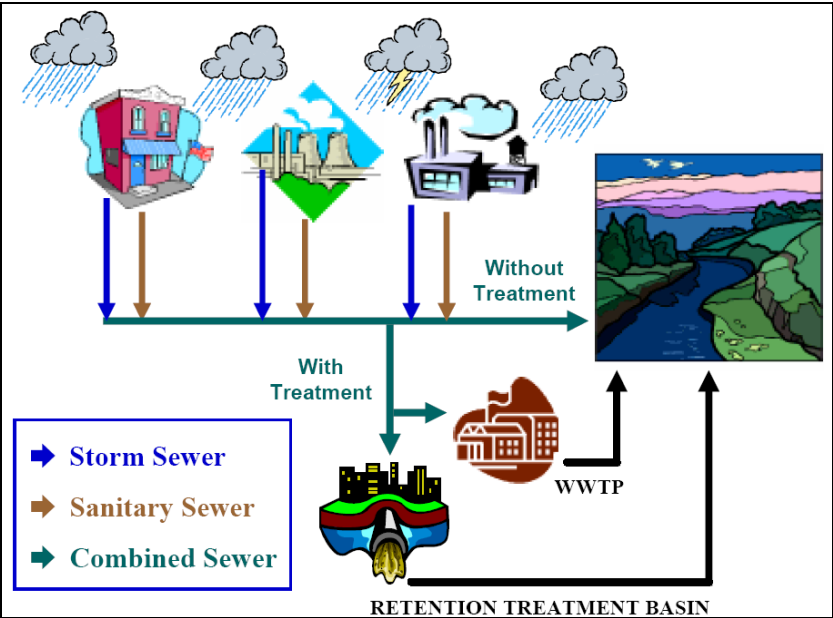
Figure 2.9 Combined Sewer System – Wet Weather Conditions (MDEQ, 2004)

Originally, many of the sewer systems in the NEW were “combined” meaning that, when it rained, they carried both stormwater and sanitary wastes in the same pipe. In a combined system, when the carrying capacity of the sewer is exceeded, they are designed to overflow into the river causing combined sewer overflows (CSOs). Increased development in CSO-serviced areas can exacerbate problems by using carrying capacity and increasing stormwater runoff. Figures 2.9 through 2.11 below illustrate the schematic of a combined sewer system in wet and dry weather conditions, and a separated sewer system.

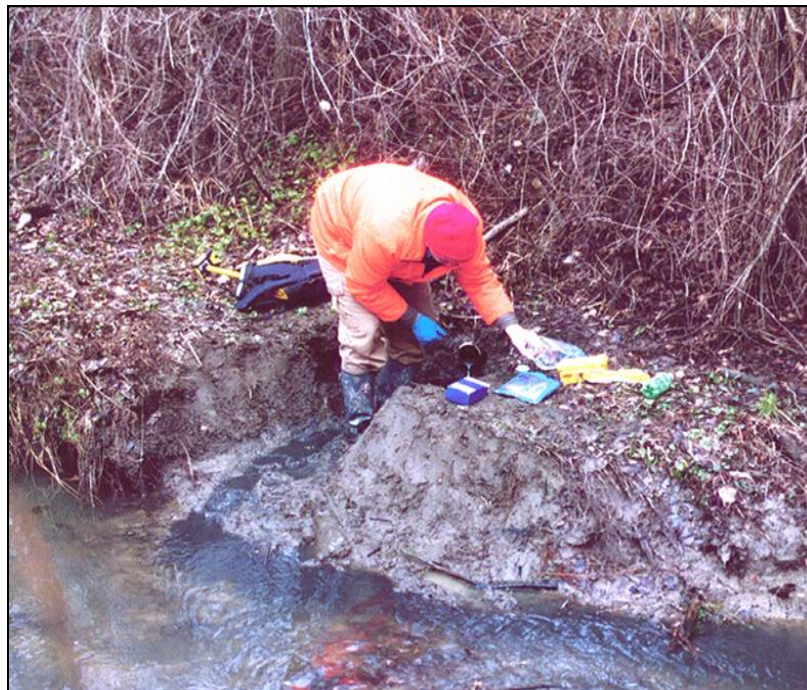
**Figure 2.13 Illicit Discharge found Discharging to Local Waterway (note discolored flow-path)**

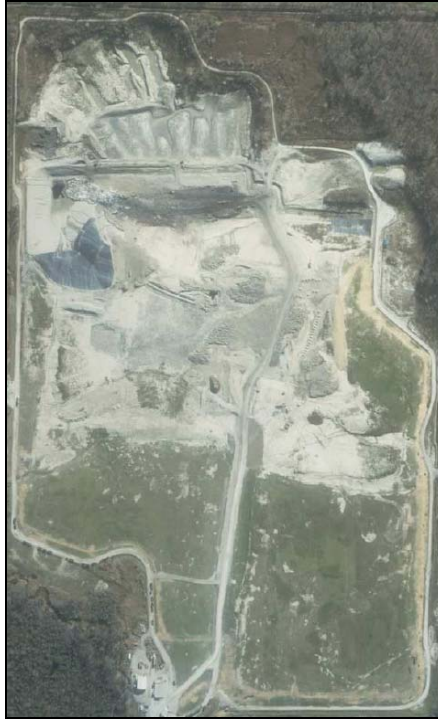
**Figure 2.15 Aerial View of Smiths Creek Landfill in Kimball Township**

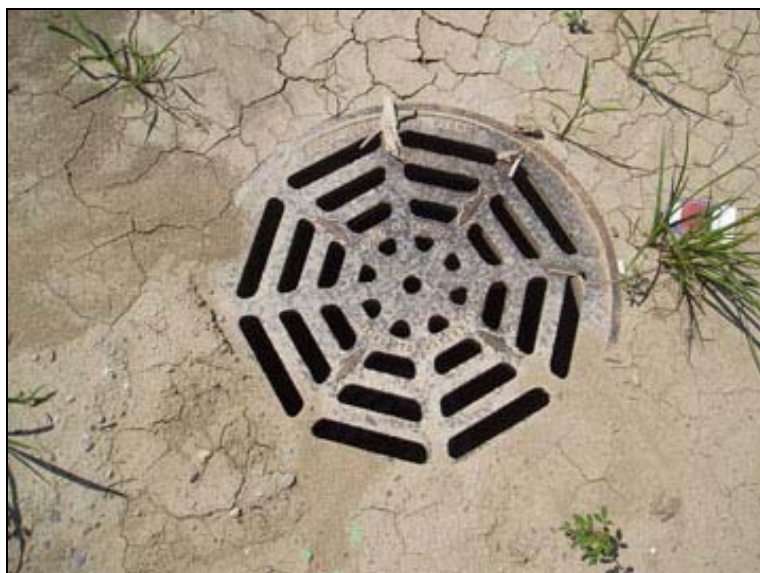
**Figure 2.16 Sediment Pathway to Surface Water through Stormwater Conveyance System**

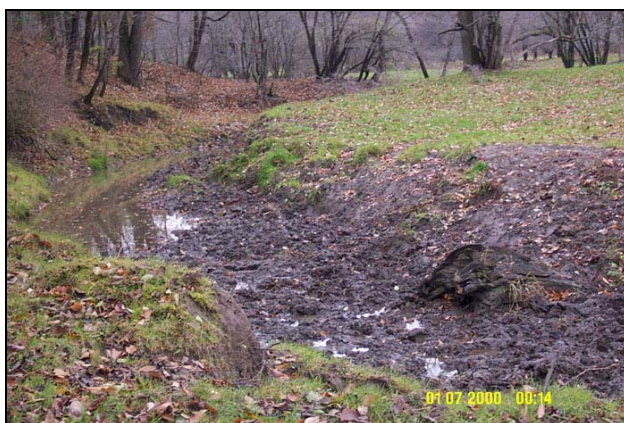
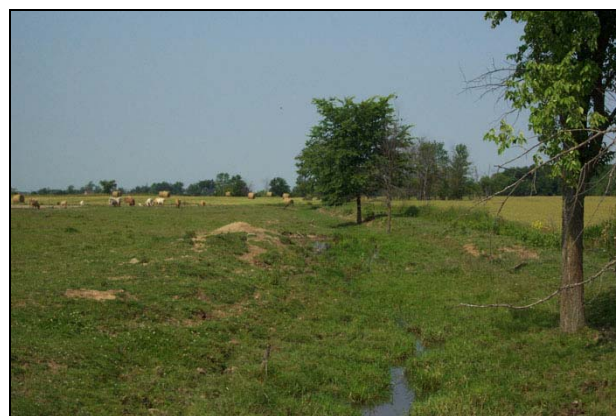
**Figures 2.17a&b Unrestricted Livestock Access to Streams**

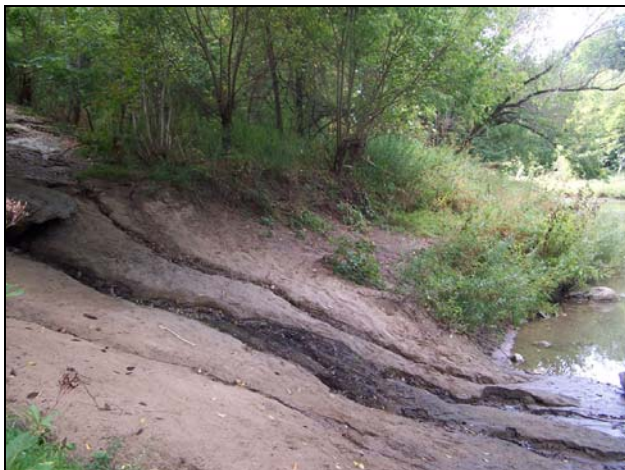
**Figure 2.18 Erosion at Road/Stream Crossing at Norman Road in the LBR Subwatershed**

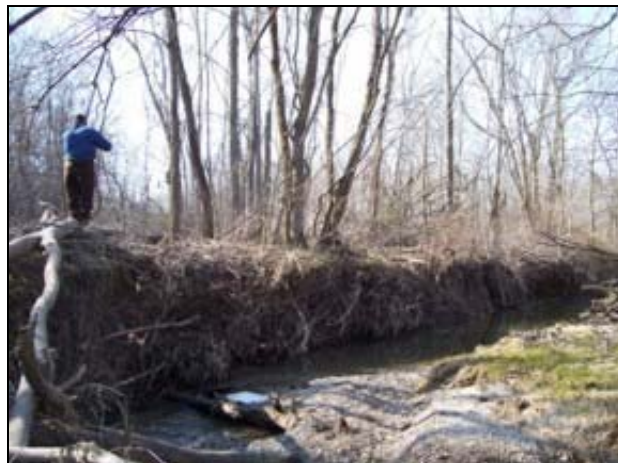
**Figure 2.19 Streambank Erosion along Burtch Creek in the LHD Subwatershed**

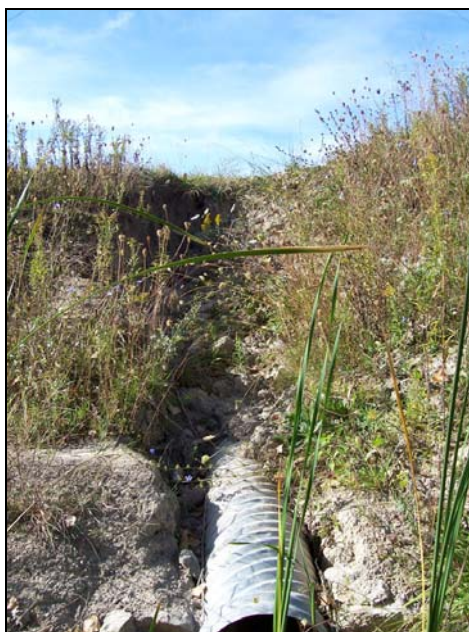
**Figure 2.20 Erosion Around Drainage Structure**

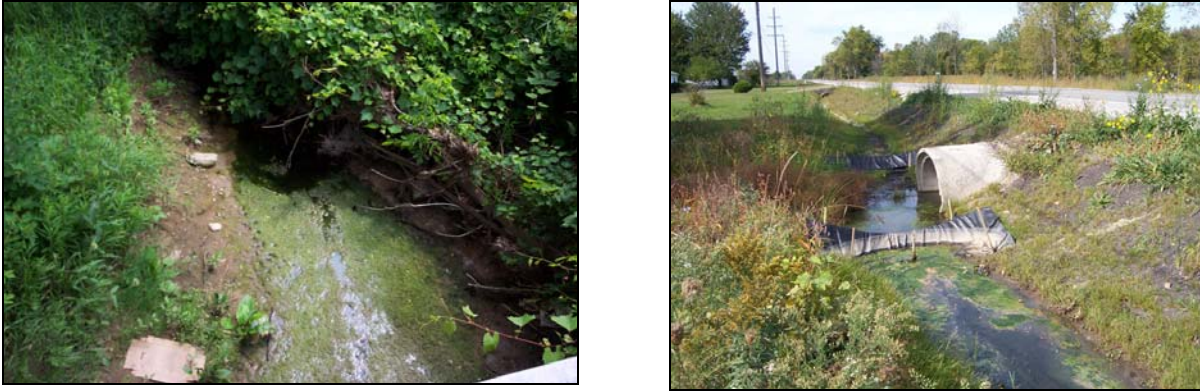
**Figures 2.21a&b Algae Growth in Local Waterway and Along Roadside Ditch**

Nitrogen and phosphorus are two important nutrients that provide plants and algae the essential elements for growth. Although nutrients are required, excessive amounts can lead to eutrophication or undesirable algae and aquatic plant growth. In eutrophic waters that become devoid of oxygen, high ammonia levels can be toxic to organisms if the pH is high (DeBarry, 2004). Several other factors can be impacted indirectly such as odors, aesthetics, dissolved oxygen, and biological communities. Evidence of excess nutrients in streams and ditches in the NEW are illustrated in Figures 2.21a&b below.

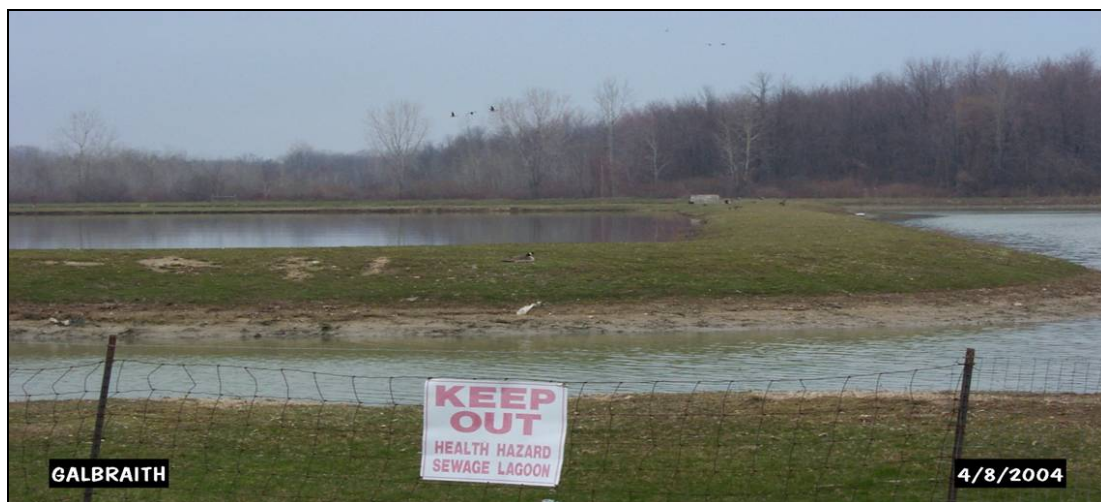
**Figure 2.22 Sewage Lagoon that Discharges to Galbraith Drain in the LHD Subwatershed**

Discharges have been documented to turn stretches of receiving streams green because of the algae present in the discharge (Figures 2.22 - 2.24).

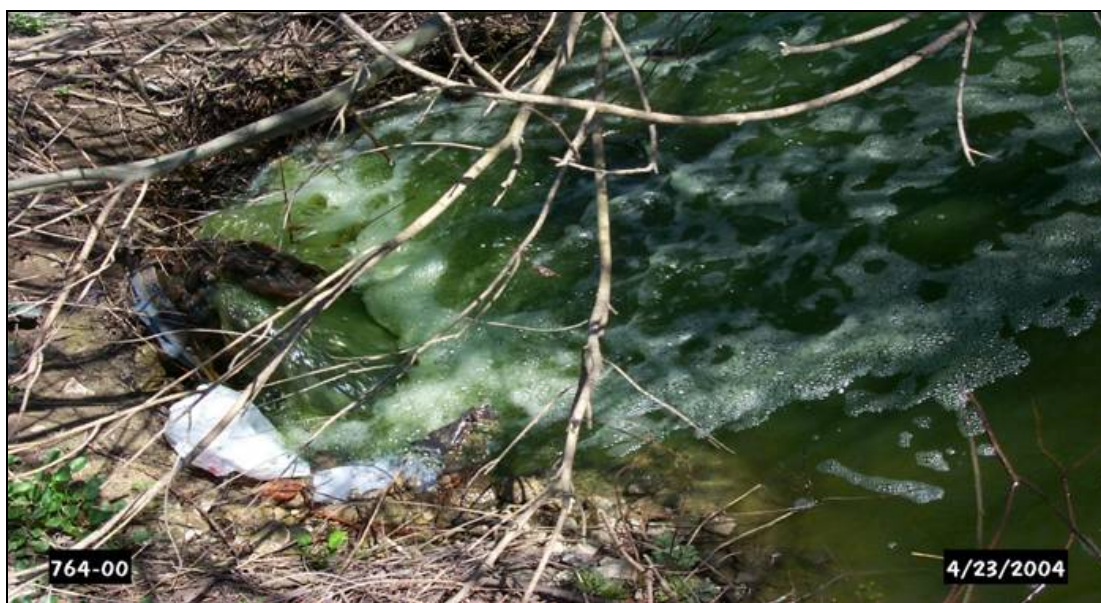
**Figure 2.23 Algae-Laden Discharge from Sewage Lagoon (note green discoloration)**

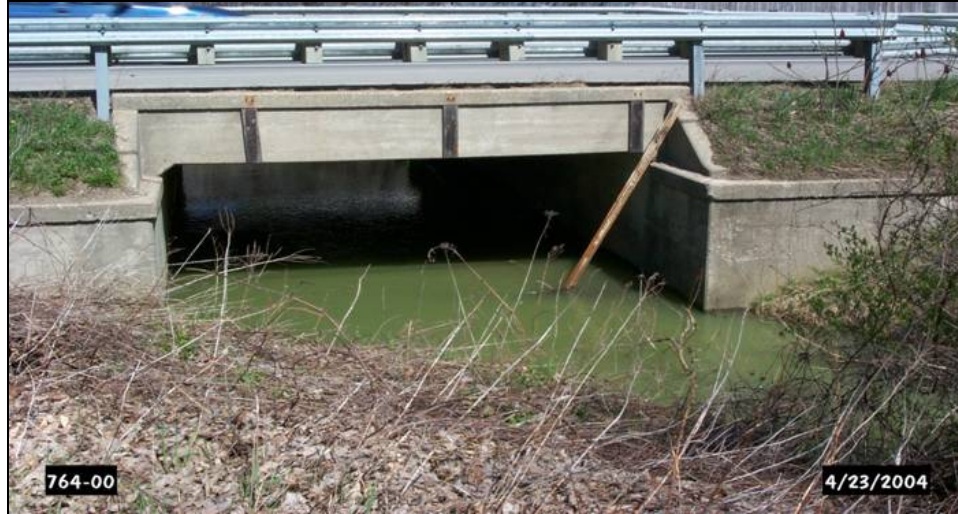
**Figure 2.24 Algae-Laden Runoff into Local Waterway (note green discoloration)**

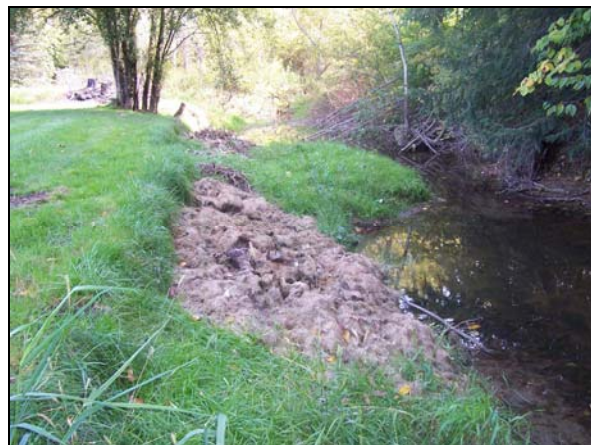
**Figure 2.25 Organic Waste Dumping along Waterway**

- agricultural runoff which may contain fertilizers and animal wastes,
- residential runoff from fertilizers and animal wastes,
- businesses,
- public parks where pet owners do not cleanup after their pets, or where waterfowl may overtake beach areas or open turf grass spaces
- illegal dumping, such as from homeowners that dump grass clippings or other organic wastes near streams as shown in Figure 2.25 below.

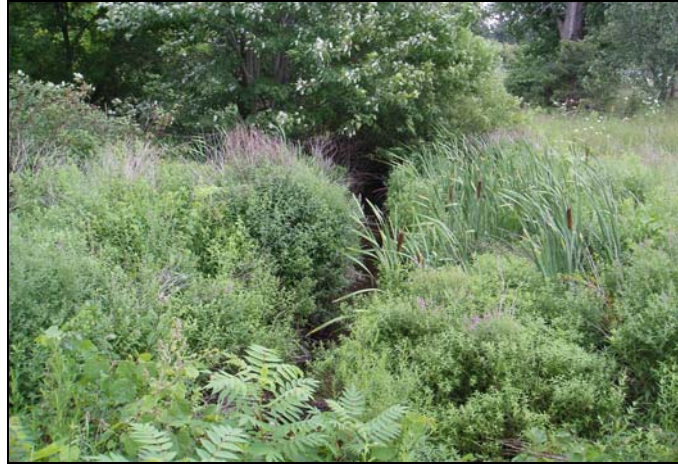
**Figure 2.26 Example of Well-Buffered Urban Stream in the LHD Subwatershed**

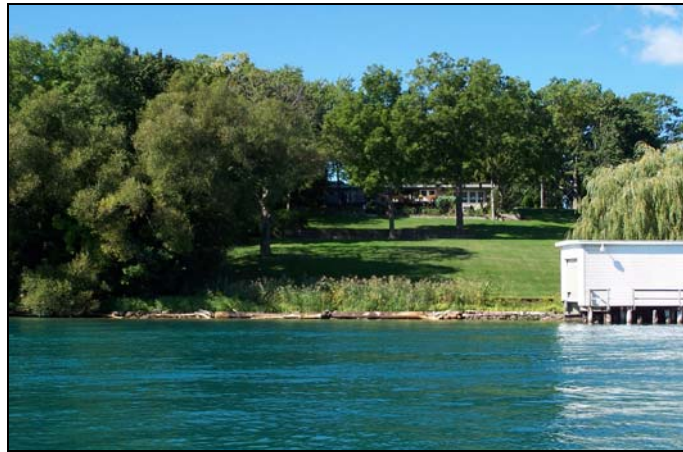
**Figure 2.27 Healthy Riparian Buffer on Residential Property along the St. Clair River**

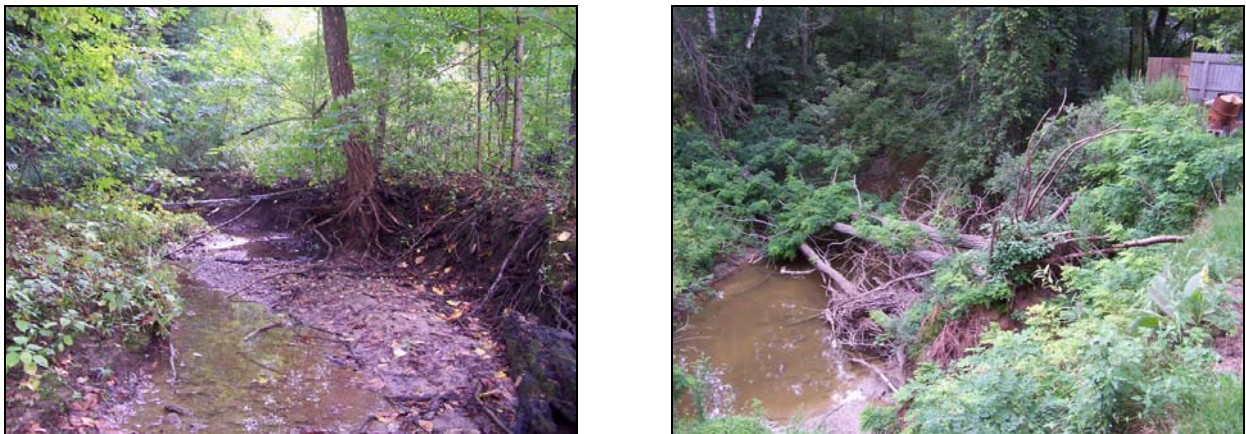
Figure 2.28 a & b Examples of Streambank Erosion in the LBR subwatershed (left) and LHD Subwatershed (right)

According to MDEQ, “hydrology is the science that encompasses the occurrence, distribution, movement and properties of the waters of the earth and their relationship with the environment within each phase of the hydrologic cycle.” Similar to streams, watersheds are in equilibrium with precipitation, surface runoff, evapotranspiration, groundwater recharge, and interflow known as the hydrologic balance (DeBarry, 2004). Land use impacts such as urbanization, deforestation, tile drainage, and loss of wetlands drastically alter the components of the hydrologic budget. Changes in discharge, sediment size or loading, or channel morphology (such as channelization) alter in-stream hydraulic factors which can lead to channel instability (i.e. streambank erosion and channel down-cutting). Figures 2.28 – 2.30 provide illustrations of these conditions.

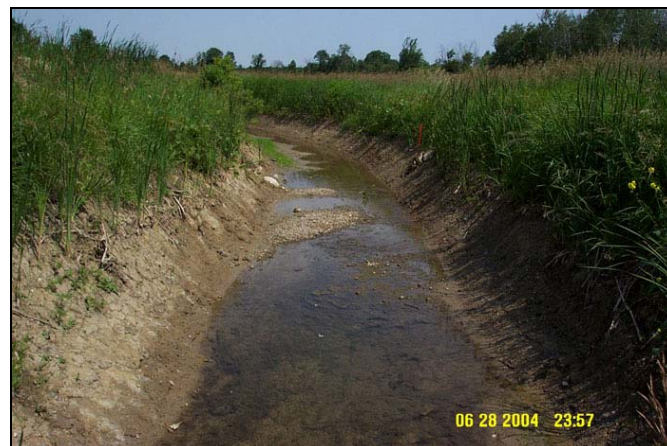
Figure 2.29 Example of Drain Maintenance along the Thomas Drain in the LHD Subwatershed

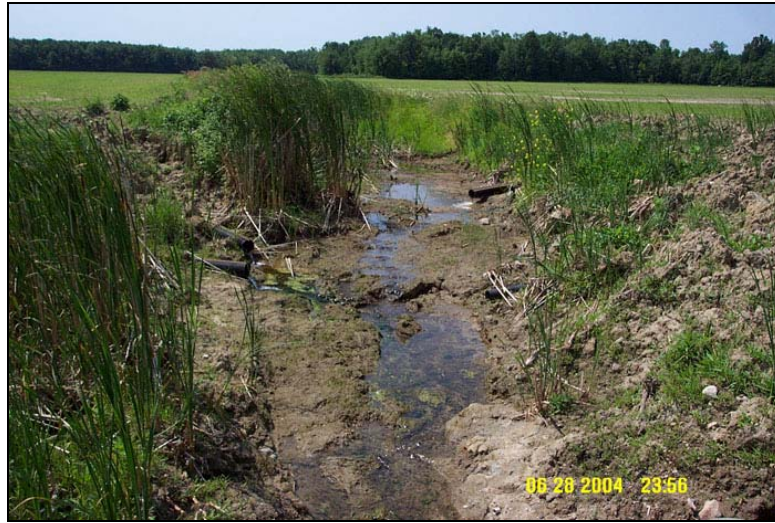
**Figure 2.30 Tile Drainage into Thomas Drain with Erosion and Nutrient Inputs**

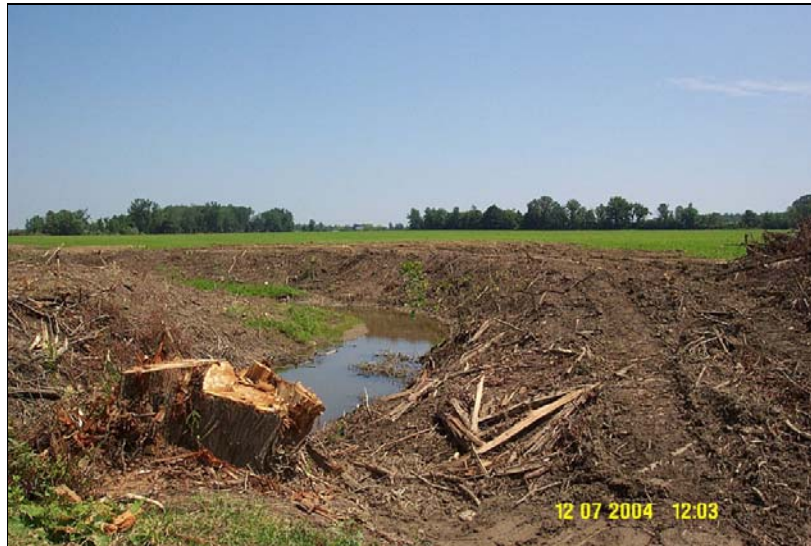
**Figure 2.31 Complete Removal of Canopy Cover and Riparian Buffer along Jackson Creek in the LBR Subwatershed**

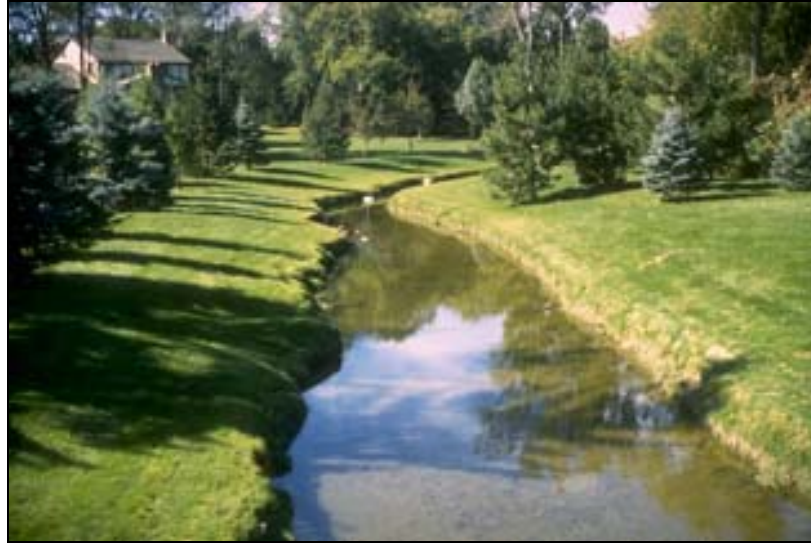
**Figure 2.32 Lack of Canopy Cover and Riparian Buffer in Urbanized Area**

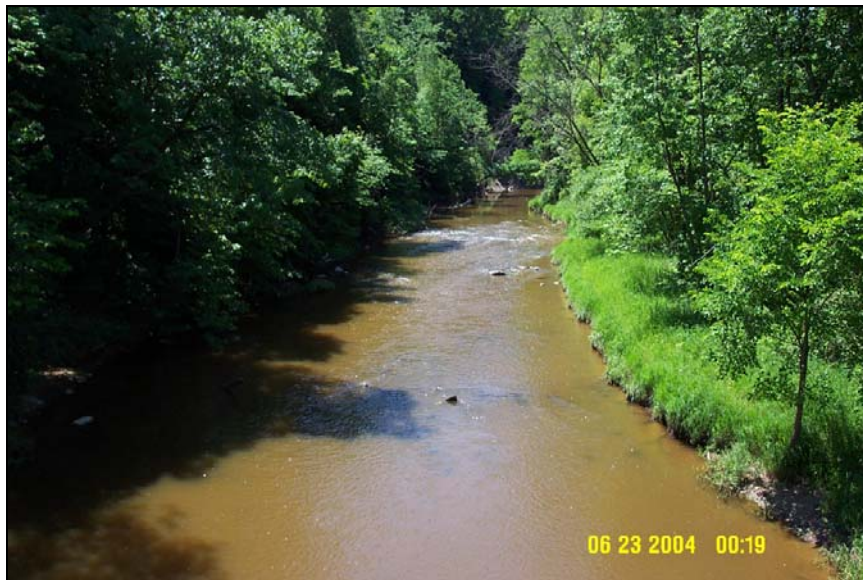
**Figure 2.33 Example of Good Stream Canopy along the Black River**

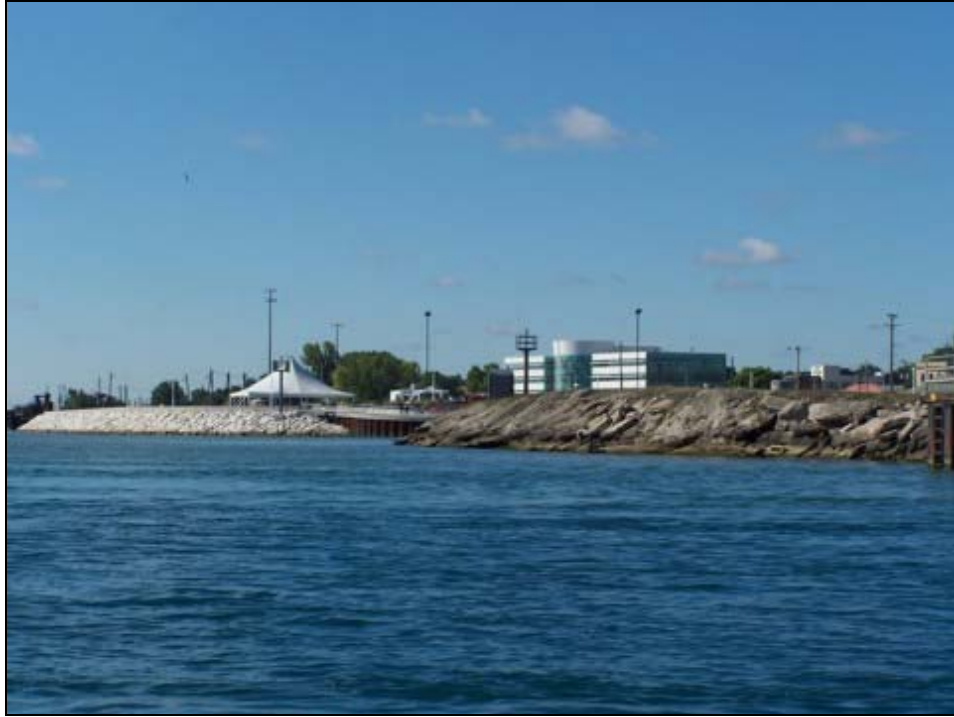
**Figure 2.34 Varying Degrees of Shoreline Stabilization along the St. Clair River**

Figure 2.34 illustrates an example of shoreline stabilization along the St. Clair River shoreline near the Acheson Property in the City of Port Huron. A more aesthetically pleasing form of stone stabilization is shown in the left of the figure whereas, on the right side of the figure, the rubble and asphalt were haphazardly placed and generally degrade aesthetics. The need for visually-appealing stabilization of steep banks, while encouraging recreational access is another priority goal in the NEW. Unsightly stabilization practices and unsafe access has been observed in many areas along the St. Clair River and at many road crossings along the Black River. These conditions are illustrated in Figures 2.34 - 2.36.

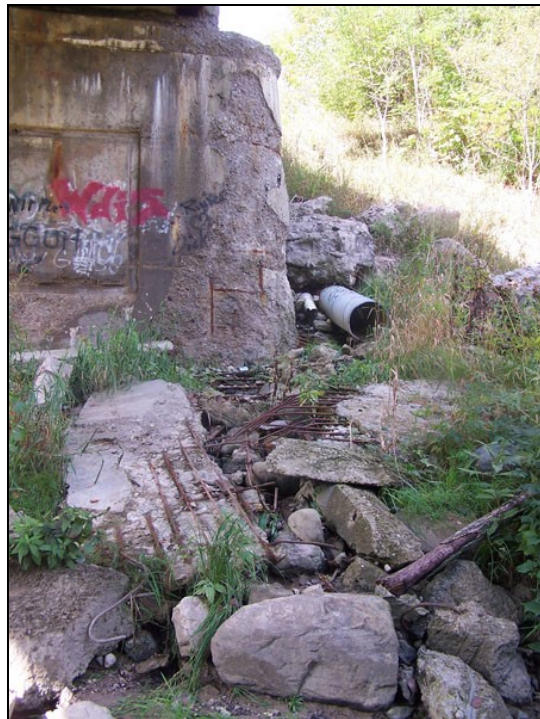
**Figure 2.35 Example of Unstable and Unsightly Public Access to the Black River**

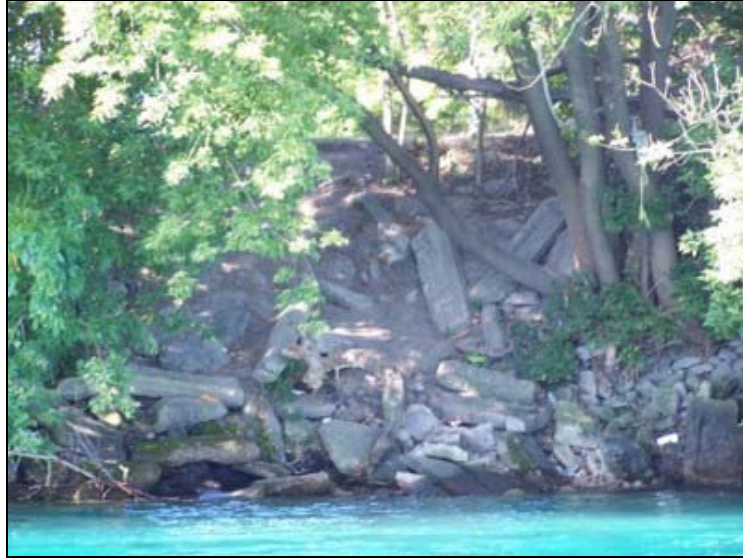
**Figure 2.36 Eroded Area at “rope swing” South of Lincoln Street**

Individuals gaining access to riverbanks for fishing commonly erode pathways to the water, especially under the bridges along the main branch of the Black River. Figure 2.36 illustrates an example of erosion along a public access site on the St. Clair River shoreline. This site is known as the “rope swing” located near the YMCA south of Lincoln Street in Port Huron.

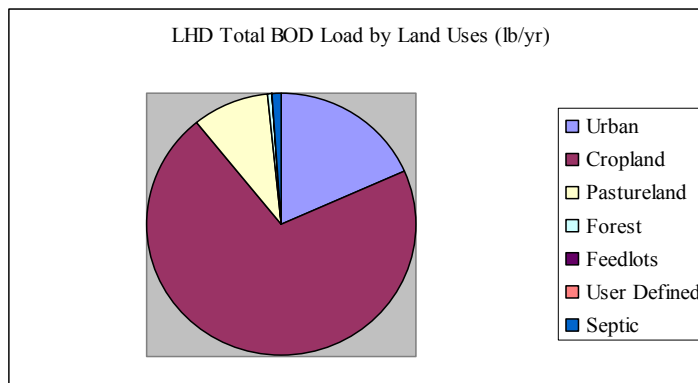
**Figure 2.41 Biological Oxygen Demand Loading (lb/yr) by Land Use per Subwatershed**

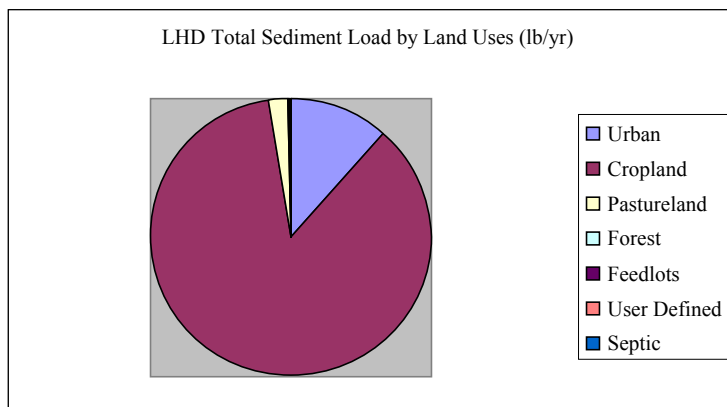
**Figure 2.42 Sediment Loading (lb/yr) by Land Use per Subwatershed**
